1.0 INTRODUCTION

This report describes a study conducted to identify, evaluate, and prioritize riparian buffer restoration opportunities on the Woonasquatucket River in Rhode Island. The study was directed by the Woonasquatucket River Watershed Council and funded by a grant from the U.S. Forest Service. Results from the study, as described below, are intended to aid future resource management decisions in the watershed. In particular, this report and its supporting information are designed to provide not only a comprehensive inventory of potential riparian restoration sites, but a tool for prioritizing and selecting projects for future funding and implementation. The study also includes guidelines for restoration design that take into account specific characteristics of the subject watershed. Finally, the study includes the identification and implementation of a demonstration restoration site in the watershed, as described in Section 6 of this report. The design work for the demonstration restoration project was completed by Kleinschmidt during the Summer of 2001, and the implementation is scheduled for 2002.

1.1 Woonasquatucket Watershed

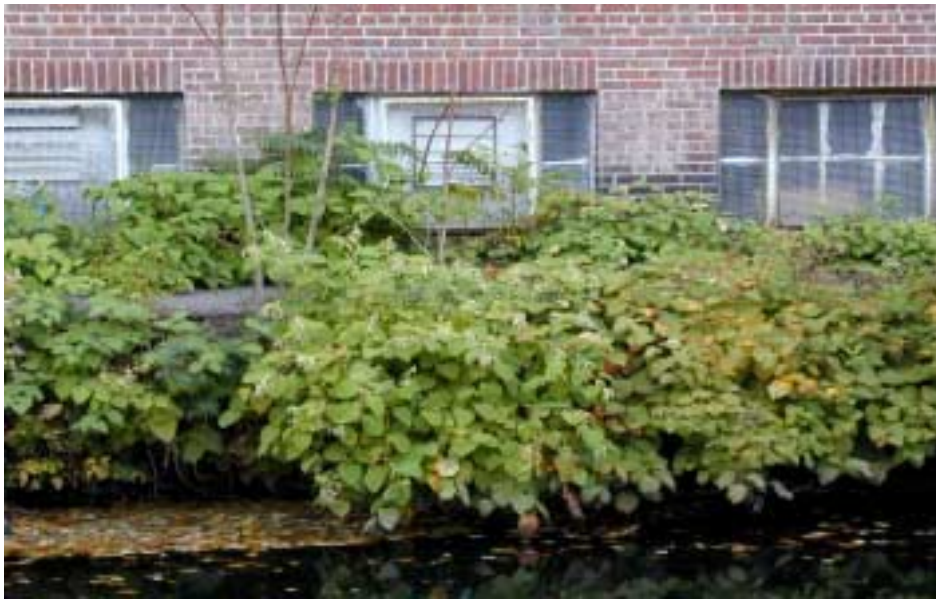
Figure 1-3. Japanese knotweed.

Japanese knotweed along a floodwall in Olneyville, Providence.

A significant component of the riparian plant community in the Woonasquatucket watershed consists of exotic and invasive species. This is especially true in the lower portion of the watershed. The most ubiquitous exotic/invasive species in the watershed is Japanese knotweed (*Fallopia japonica*) (Figure 1-3). A more detailed description of the exotic/invasive species in the watershed is presented in Section 5. However, even in the lower portions of the River, in and near Providence, there are relatively undisturbed riparian buffers that lack a dominance of exotic/invasives. Such sites are called "reference sites" which are relatively intact, undisturbed forested riparian buffers that are dominated by native vegetation and natural soil profiles (Figure 1-4). These sites typically provide riparian buffer functions at target levels, and their characteristics can help with restoration designs. For example, riparian buffer site designs for the Woonasquatucket River should attempt to use native plants characteristic of undisturbed portions of the River (*i.e.*, reference sites), if commercially available, since these plants are known to thrive in the local conditions.

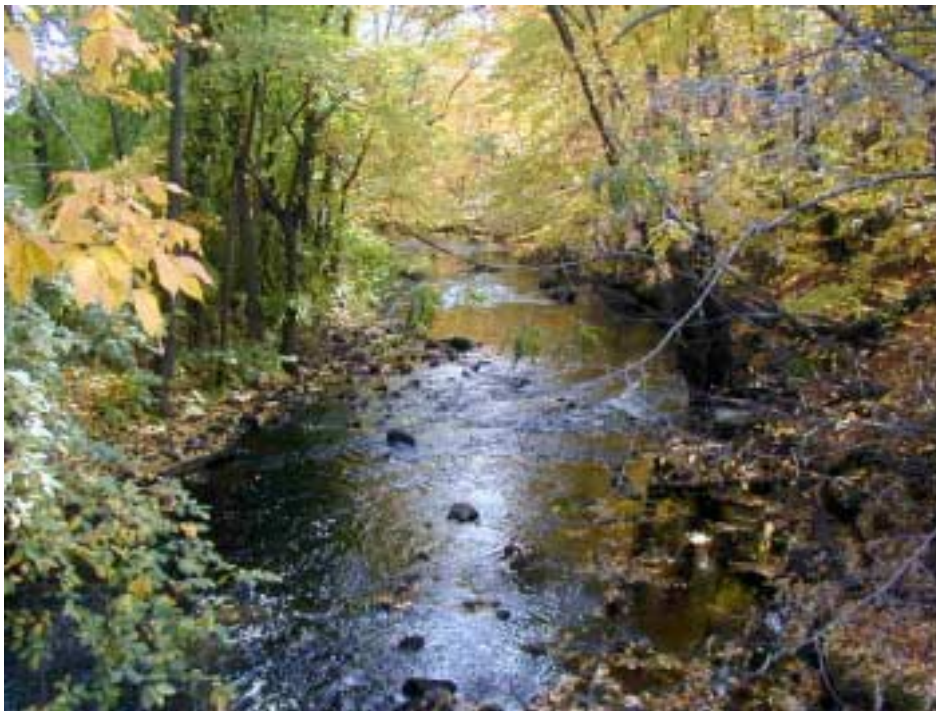
Figure 1-4. Reference condition.

This relatively undisturbed riparian buffer is just downstream from the Allendale Mill Dam in Johnston and North Providence. Native species such as green ash, red maple, red oak, black cherry, and American elm dominate the tree stratum.

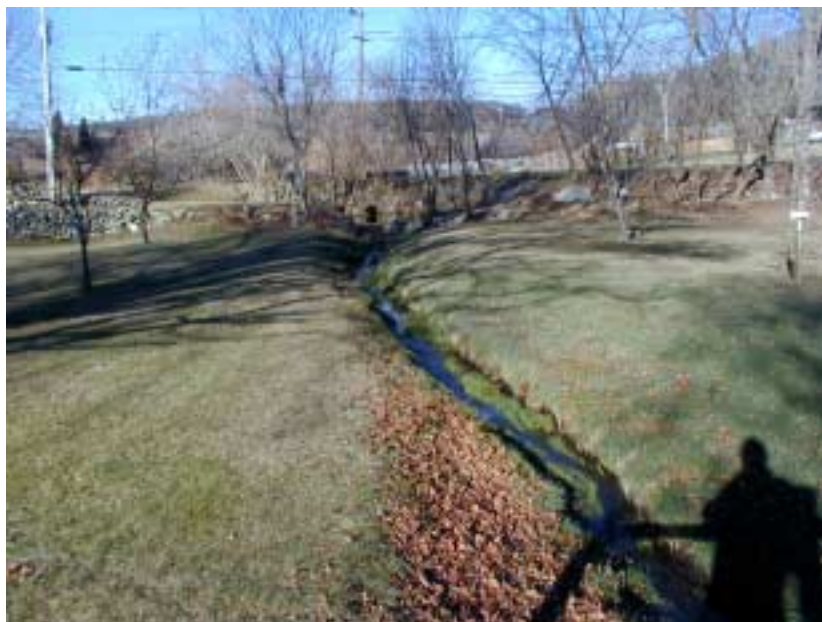
The ***Smith Appleby*** site has several deficiencies with regard to optimal function. Possible design components to address corresponding deficiencies are summarized in Table 5-2.

Table 5-2. Smith Appleby Site - Deficiencies and Corrective Design Components.

Deficiency	Corrective Design Component
Site grades smoothly and consistently to the stream	Add topographic complexity. Grade site so that a portion of the land slopes away from the stream. Incorporate swales that will promote infiltration. Design topography to discourage concentrated surface flows perpendicular to contours.
Stream is channelized	Modify channel to make more natural. Install natural stream-bed substrate (<i>e.g.</i> , appropriately sized boulders, rocks, cobbles, pebbles, sand). Incorporate sinuosity. Use a fluvial geomorphologist to determine appropriate sinuosity and bed materials according to contributing drainage area and flow regimes.
Mowed lawn to stream edge.	Discontinue mowing. Plant a diverse community of native woody vegetation.
Exotic/invasive (<i>e.g.</i> , Norway maple) is dominant tree on and near site.	Control exotics and promote natives if wildlife habitat and plant diversity are a priority. Retain existing mature trees but plant natives in understory if primary objective is water quality. The hope is to shade-out seedling establishment of the Norway maple so that when the canopy trees finally die-off the site will be mostly natives.

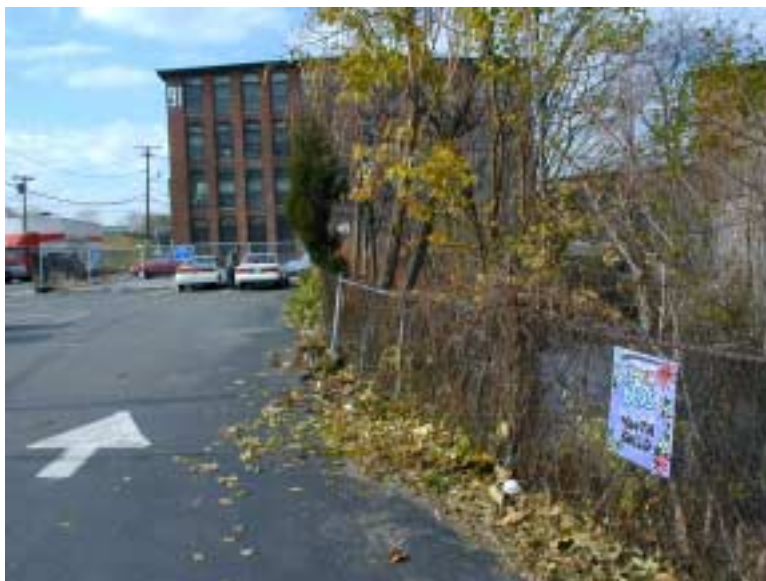
Figure 5-2. Olneyville Post Office Parking Lot (P09).

As with many of the potential restoration sites in Providence, the ***Olneyville Post Office*** parking lot site had a floodwall at the river margin and was dominated by impervious surfaces. Typically, restoration sites dominated by impervious surfaces and floodwalls will have the greatest restoration costs of all projects, but also have very high functional gains. Due to extremely high costs, projects involving impervious surface removal often require partnerships.

When impervious surfaces are removed from historical industrial areas, it is necessary to consider the possibility of soil contamination. Even if soils beneath impervious surfaces are not contaminated they will likely be devoid of organic matter (*i.e.*, the soils have become sterile) and will require significant soil amendments, such as topsoil addition.

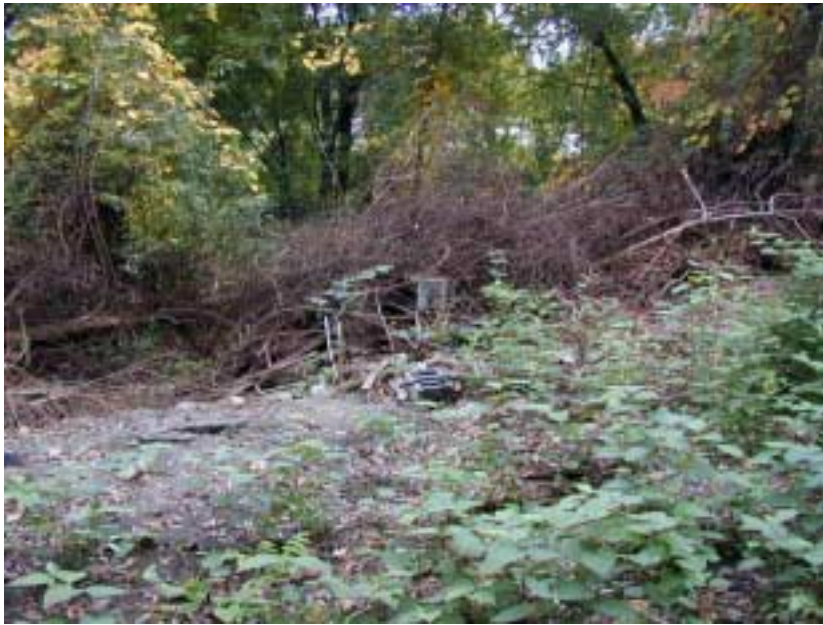
Figure 5-3. Behind Stop-N-Shop Grocery Store in Manton (P18).

The ***Manton Stop-N-Shop Grocery Store*** site contains recently disturbed soils with small Japanese knotweed sprouting vegetatively (*i.e.*, not from seed). Left unmanaged a pure monoculture of mature knotweed will form and will persist indefinitely. This will have a negative effect on native plant diversity and on wildlife habitat. As such, mechanical or

chemical removal is recommended if possible. However, if the primary objective is water quality maintenance, exotic/invasive plants are often as good or better at stabilizing soils and

assimilating nutrients.

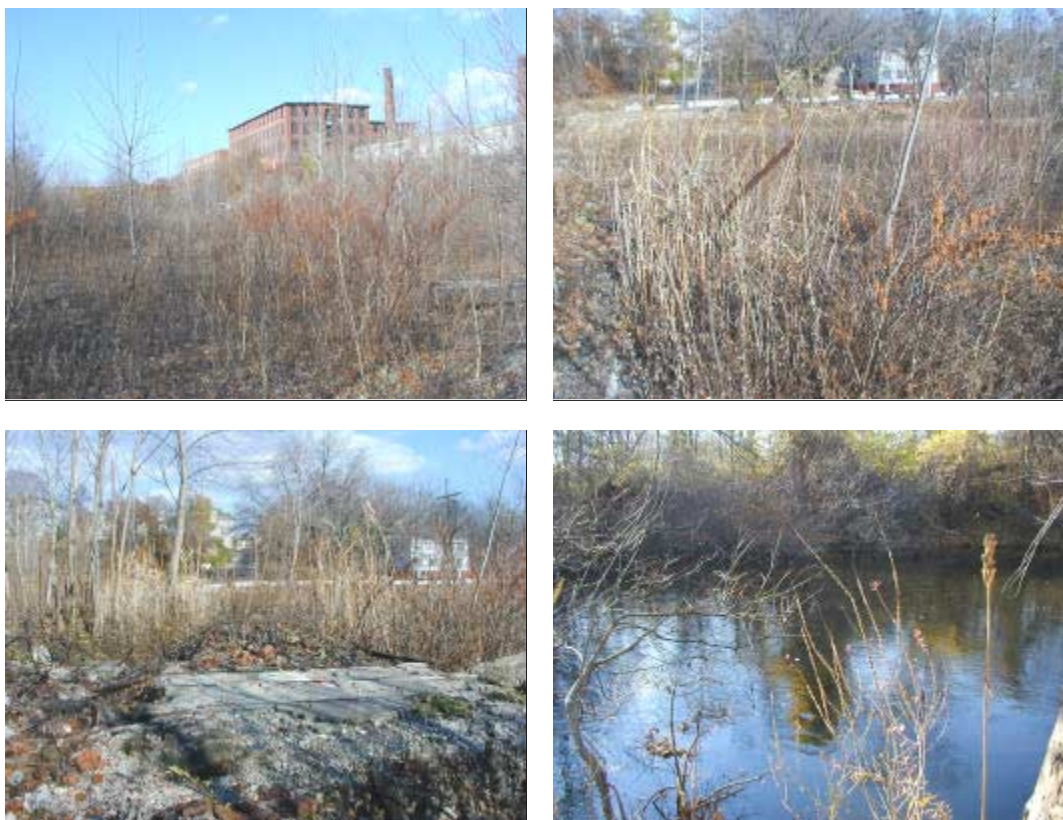
Figure 6-1. Riverside Mills Project Demonstration Site – Representative Photos of Existing Conditions.

An early successional vegetation community typical of disturbed soils has established on the old mill site (upper left). A variety of exotic invasives including common reed (left center of photo) have become established (upper right). The cut and fill soils (Udorthents) on the site are relatively sterile and lack organic matter. Also, there is a fair amount of debris such as brick and concrete slabs on the site (lower left). There are no floodwalls or eroding banks at the immediate river margin, however, exotic species such as purple loosestrife (center of photo) are interspersed with native species like sweet pepperbush (left side of photo) at the river edge (lower right).
